FATHOM

The Naval Safety Center's Afloat Magazine

Jan-Mar 1999

Volume 31, Number 1, 1999

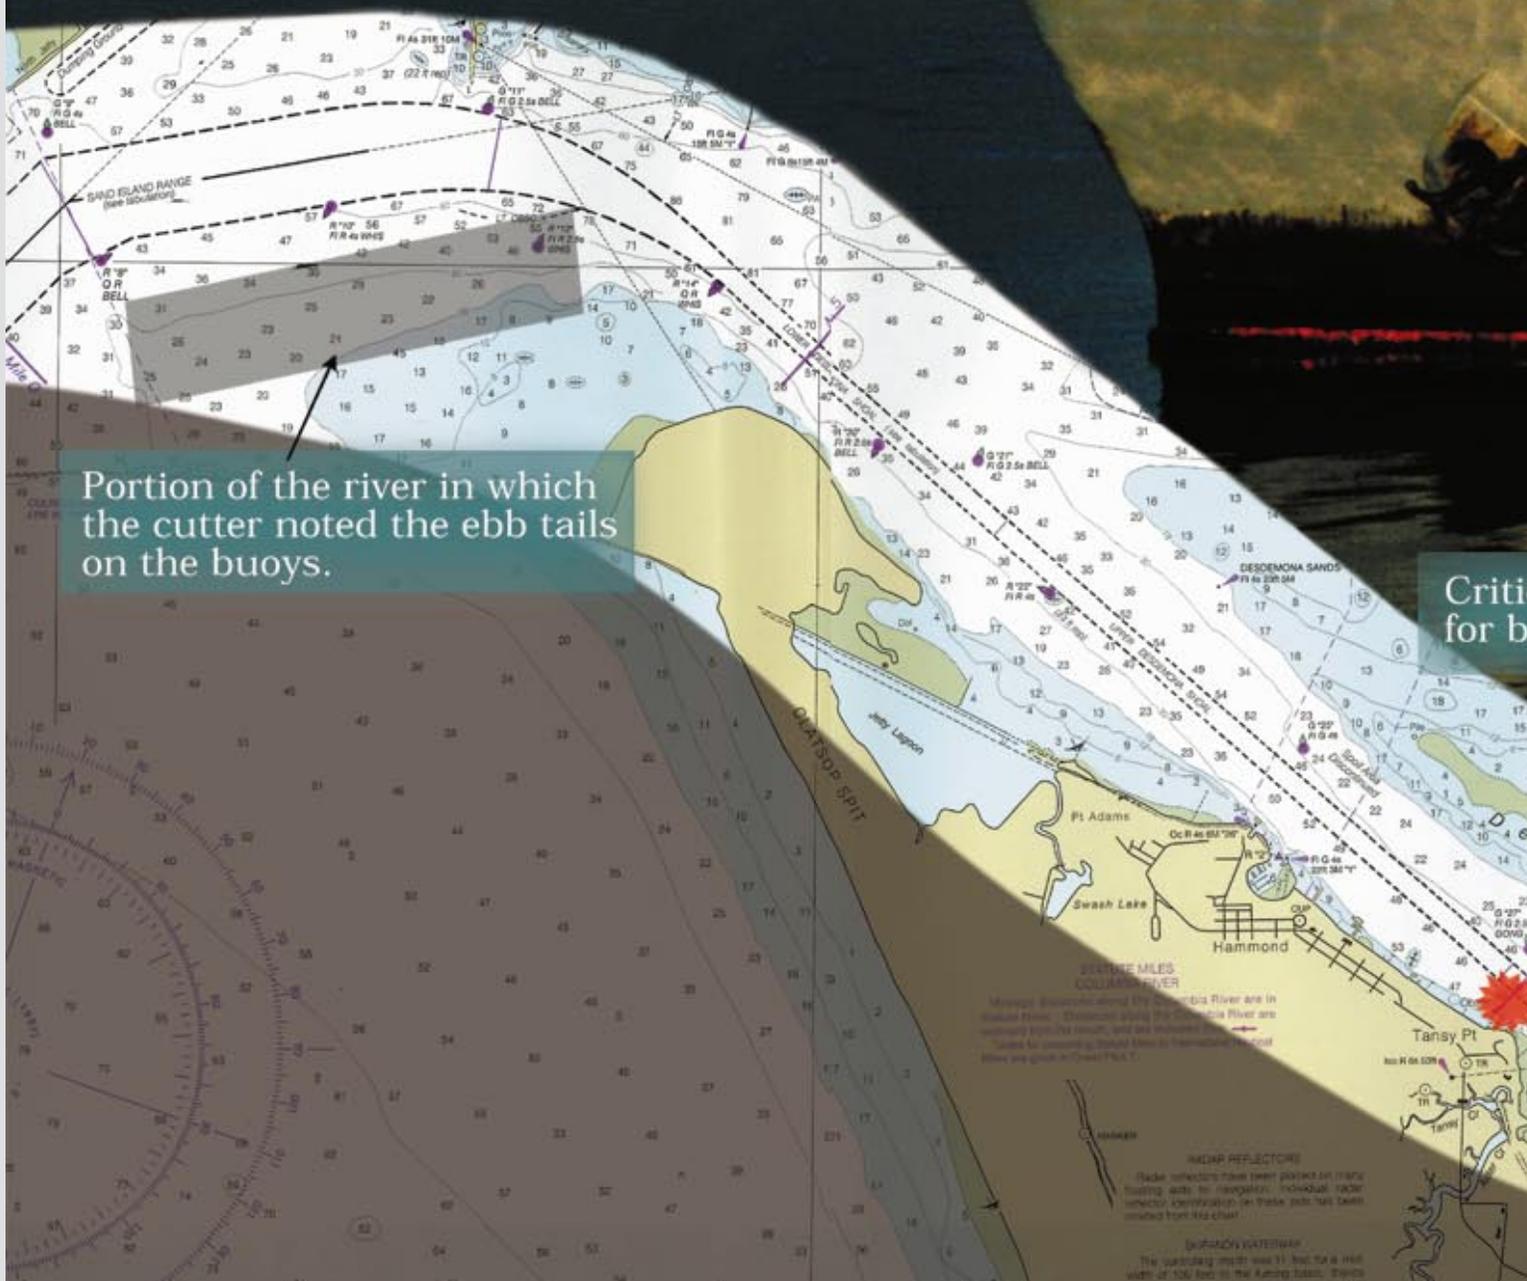
Portion of the river in which
the cutter noted the ebb tails
on the buoys.

Major hazards along the Columbia River are in
black boxes. Obstructions along the Columbia River are
indicated by the number, and the maximum depth
is shown in parentheses. Details of the river are
shown in Chart 7117.

Although the current was predicted to be flooding, several bridge watchstanders saw ebb tails on passing buoys in the Sand Island Range Reach. As the cutter entered the Desdemona Shoal Reach, the CO ordered the plotter to recalculate set and drift. The plotter noted a one-and-a-half-knot ebb along the channel axis, which agreed with visual observations.

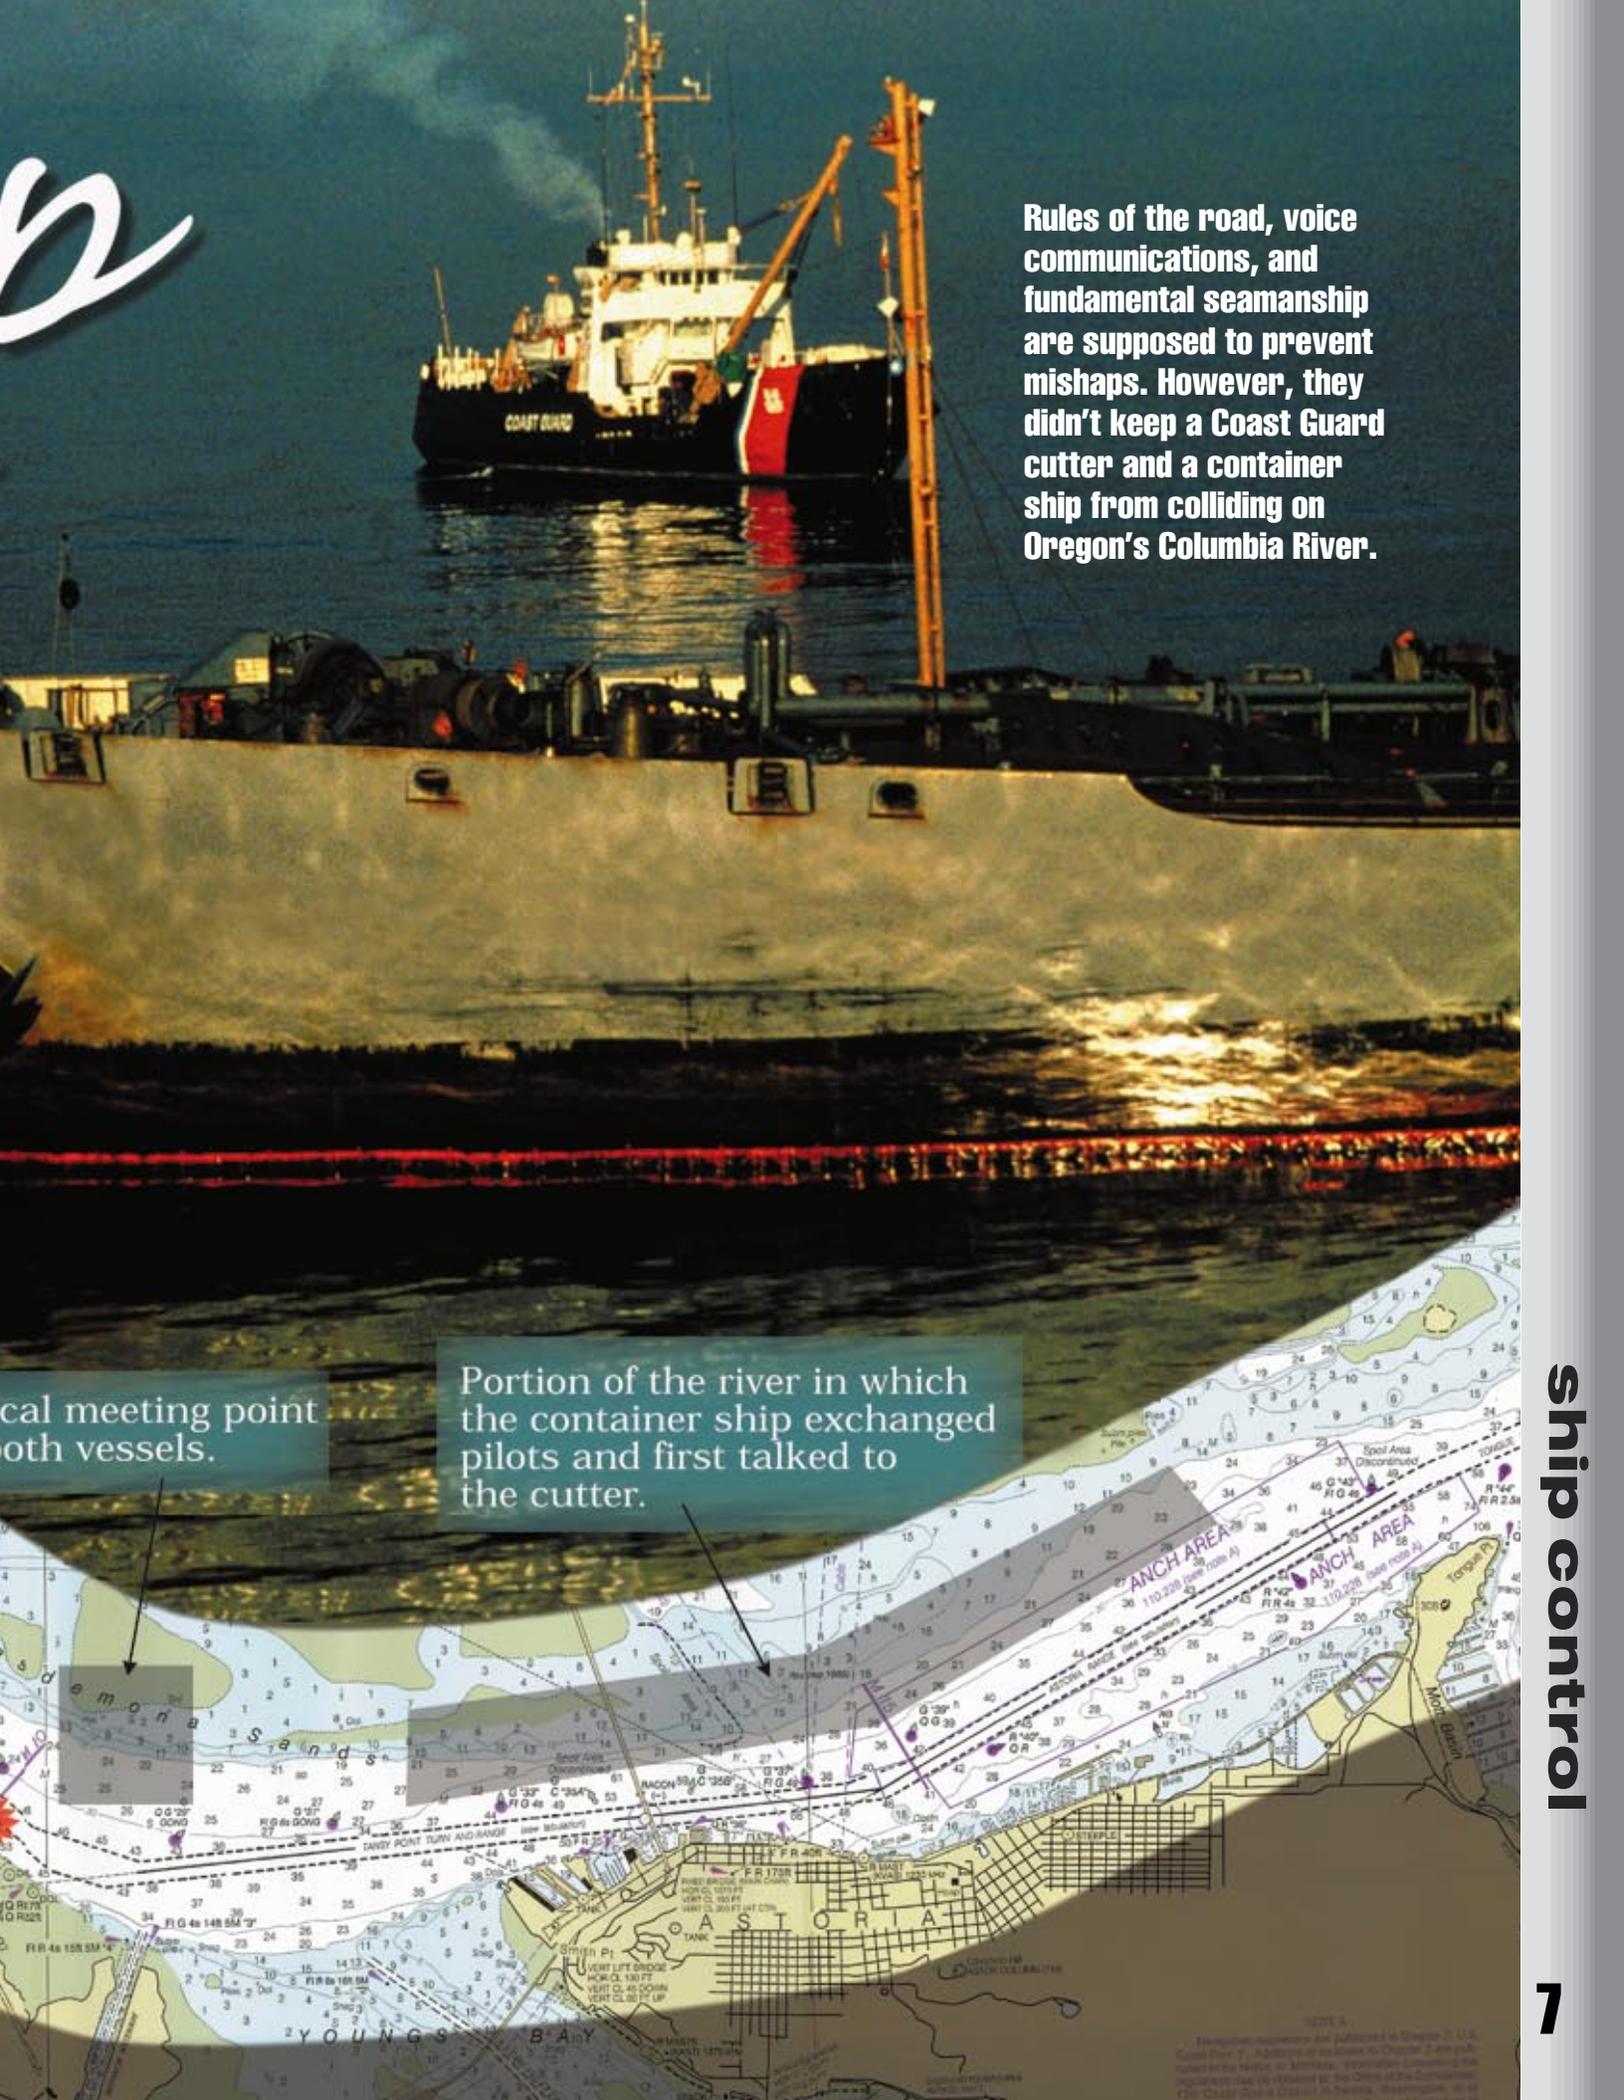
Local meeting point of both vessels.

Portion of the river in which the container ship exchanged pilots and first talked to the cutter.

At 2055, the outbound container ship exchanged its river pilots for a bar pilot while in the Astoria Range Reach. At 2102, the bar pilot ordered half ahead, which, for the container ship, meant 12 knots. The pilot testified he believed it would take about 30 minutes to achieve that speed. He remained at half ahead throughout the transit. At 2107, while passing under the Astoria Bridge, the pilot made a security call on channel 13. He announced his location, direction and 36-foot draft.

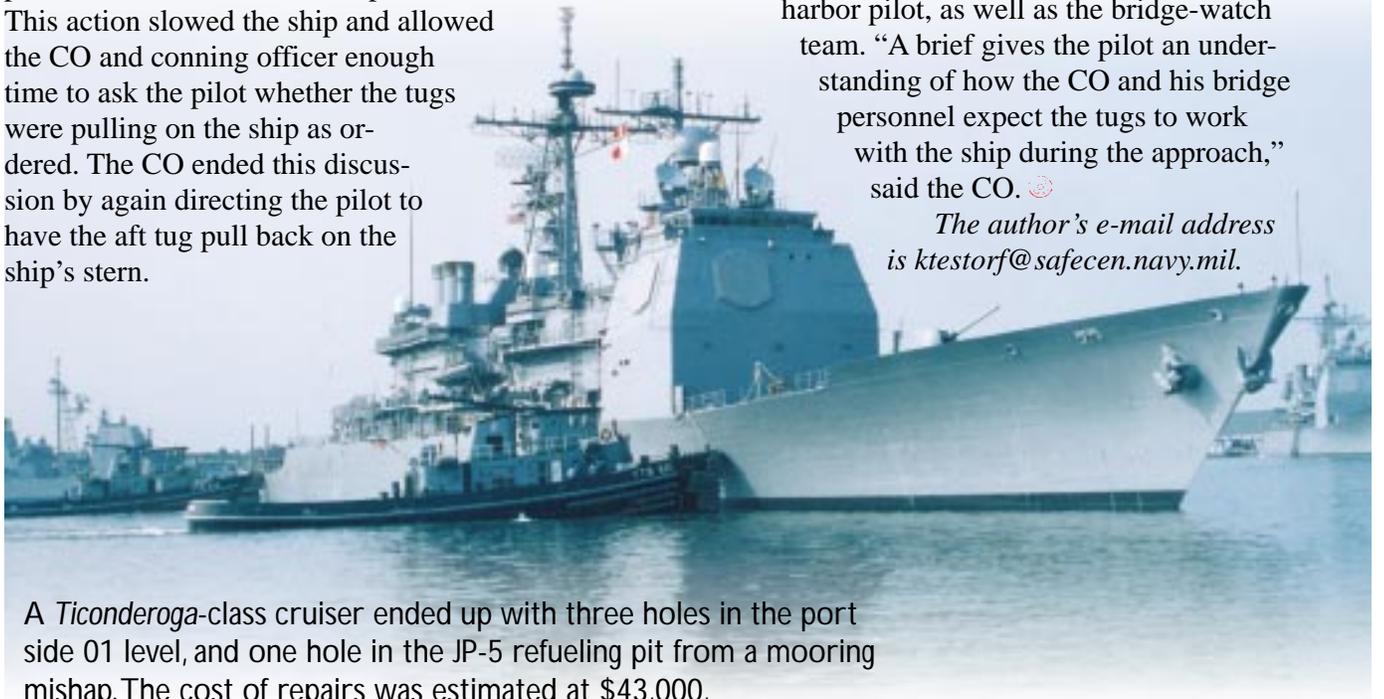
A Ticonderoga-class cruiser ended up with three holes in the port side 01 level, and one hole in the JP-5 refueling pit from a mooring mishap. The cost of repairs was estimated at \$43,000,

Damage to the ship from this mishap included three holes in the port side, 01 level, and one hole in the JP-5 refueling pit. These holes ranged in size from 3.5 inches by 3 inches to 6 inches by 14 inches. There also was cosmetic damage to three spots on the pier, where the boat boom dragged along its edge. The cost of repairs to the ship was estimated at \$43,000.

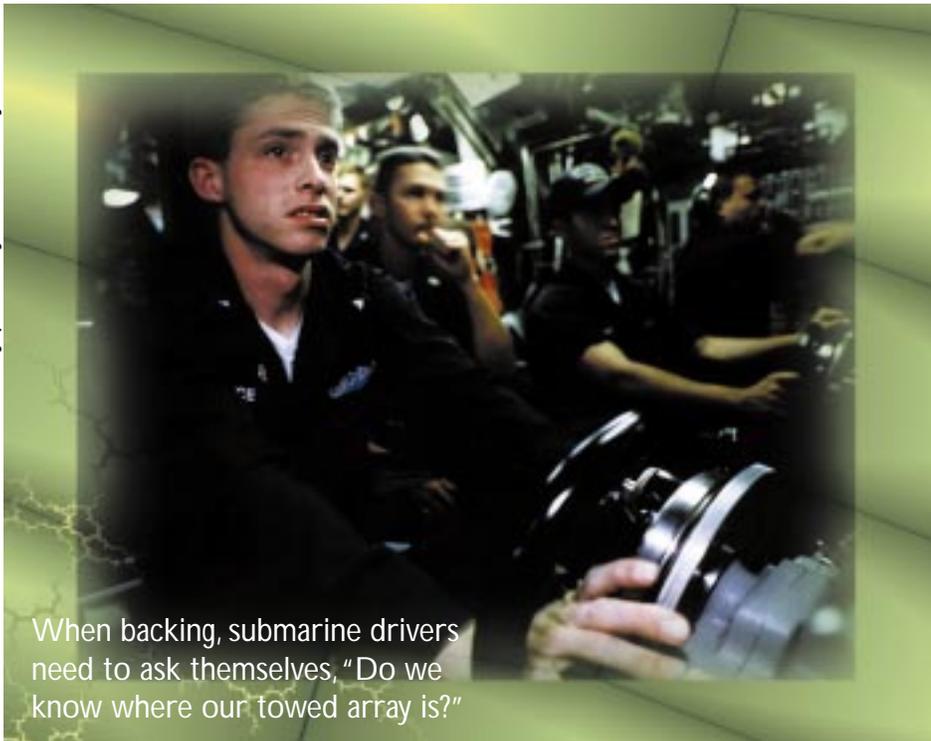
When backing, submarine drivers need to ask themselves, "Do we know where our towed array is?"

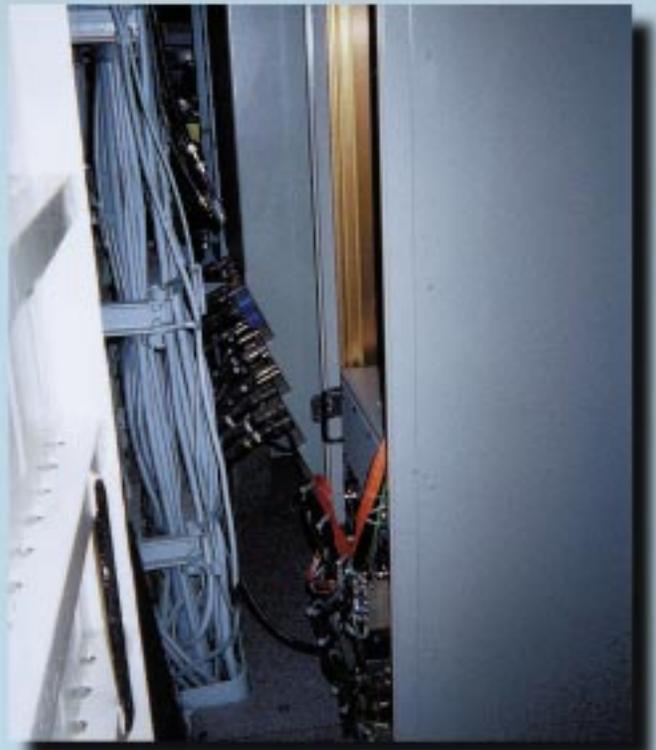
On one ship, safety surveyors found this unattended, unsupervised, unprotected IC cabinet, with exposed 450-VAC wiring—and no tagout.

It's not surprising that so many people are getting shocked when you consider the electrical problems safety surveyors uncover. For example, we found an unattended, unsupervised, unprotected IC-switchboard section with exposed wiring. This switchboard still was energized!

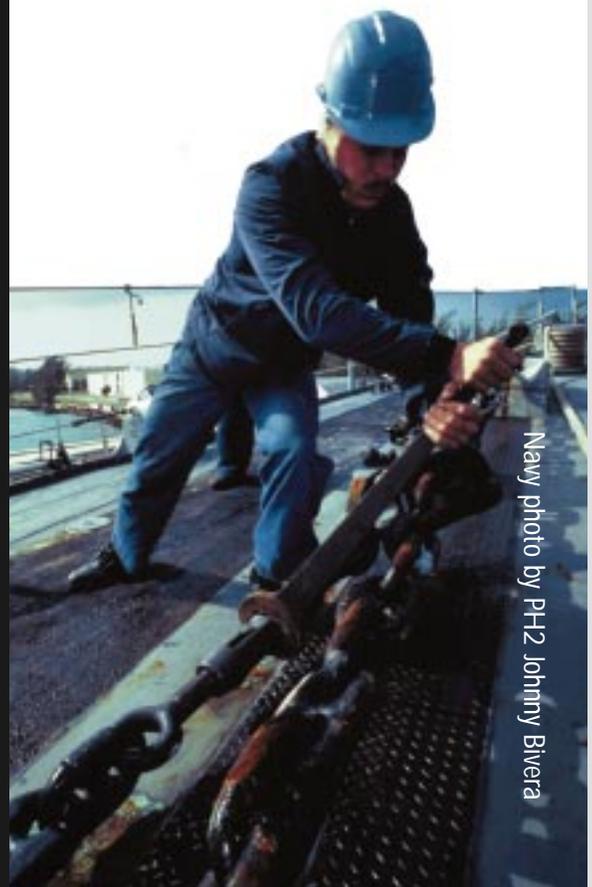
A deckhand tightens the turnbuckle on a chain-stopper. (This Sailor's pants legs should be tucked in his socks.)

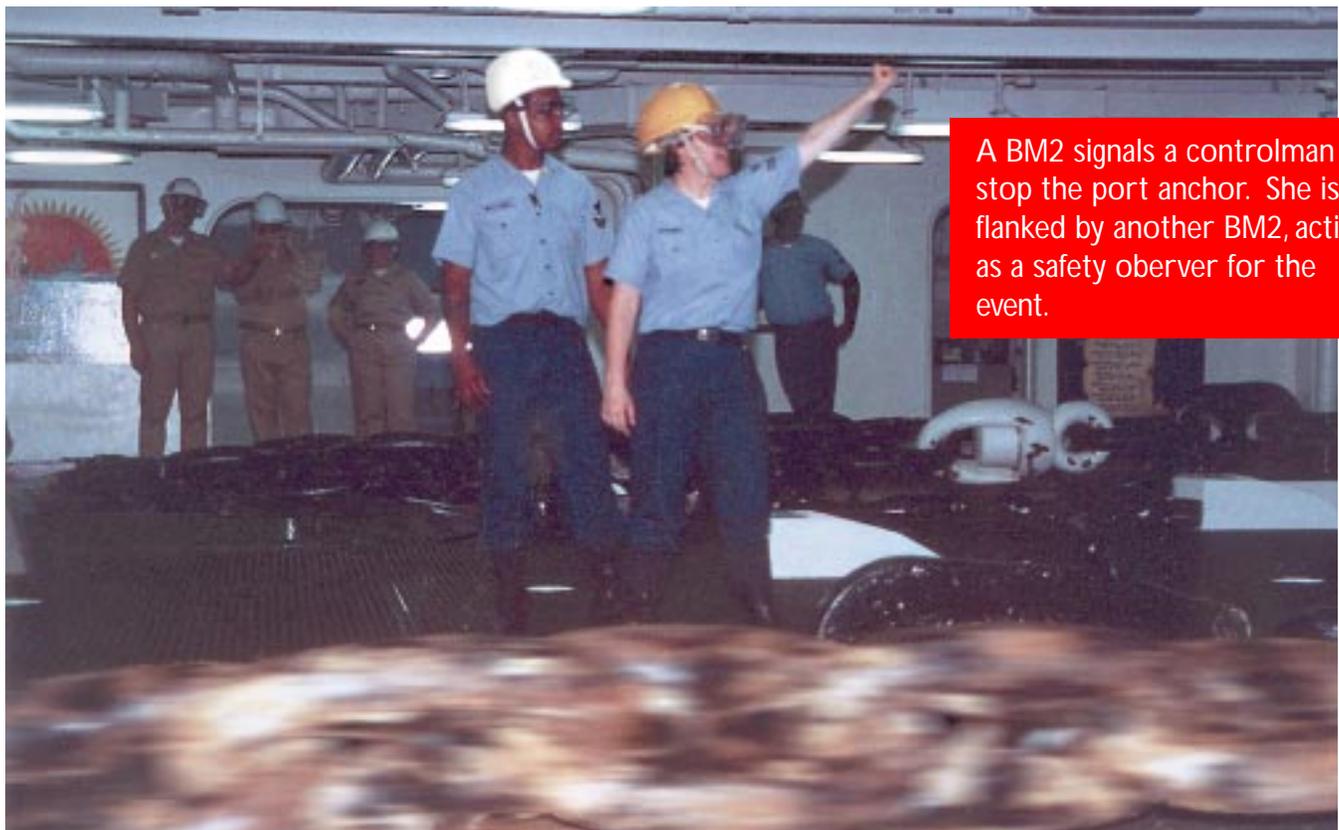
A BM2 signals a controlman to stop the port anchor. She is flanked by another BM2, acting as a safety observer for the event.

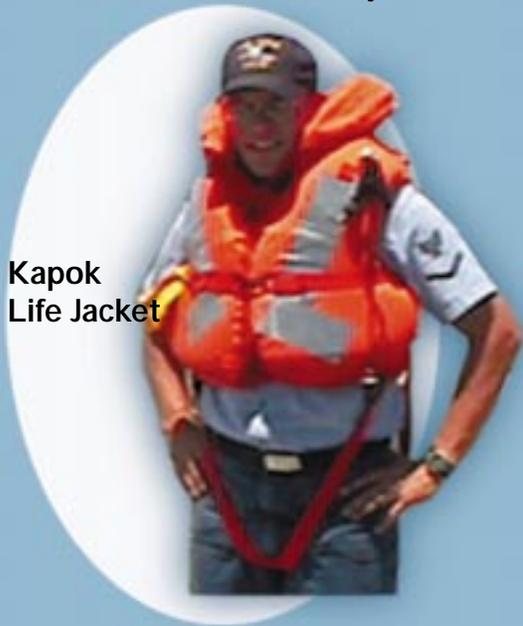
**Kapok
Life Jacket**

Kapok: Vest-Type With Collar, Type 1

Kapoks remain available in the supply system, and there are no plans to change the allowance quantities.

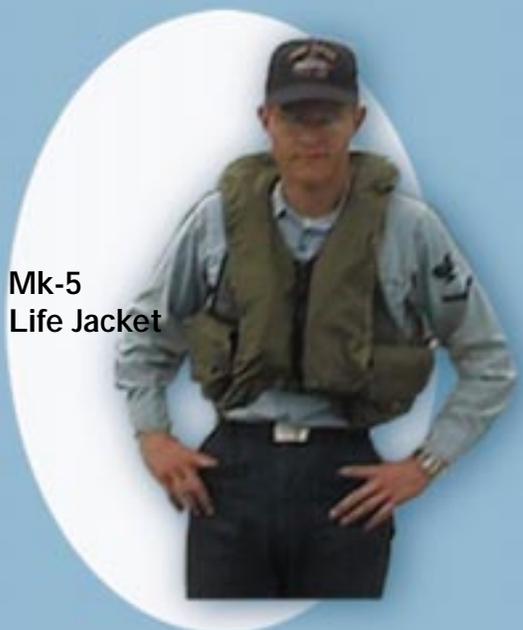
**Mk-5
Life Jacket**

Mk-5: Auto-Inflatable Utility Life Preserver (AIULP)

Because of problems with the auto-inflation device and other design issues, the Navy is phasing out the Mk-5 in favor of an updated version of the Mk-1 flight-deck life preserver. Until this shift is complete, you can get spare parts, but you can't order new jackets to replenish the current supply-system inventory.

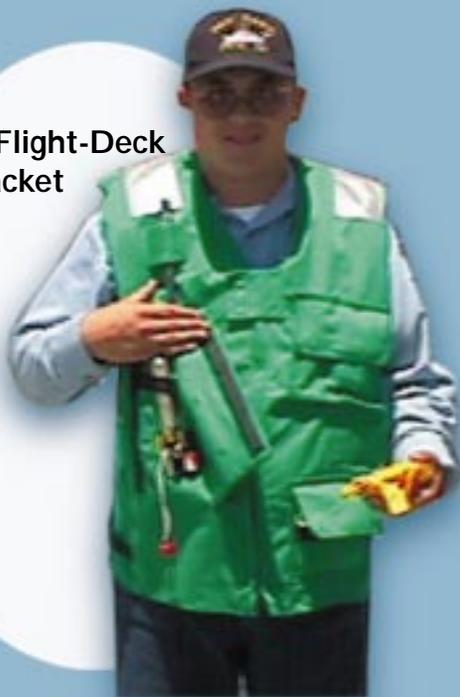
**Mk-1 Flight-Deck
Life Jacket**

Flight-Deck Jacket: Mk-1 Vest-Type Life Preserver

A non-explosive (chemically non-reactive) version of the auto-inflation device is undergoing fleet testing and should replace the current device, which uses CO₂. When ordering the Mk-1 life preserver, you may receive one with the snap-type or zipper-type front. Both designs have the same stock number. Preservers with the snap-type fronts will be issued until stocks are depleted.

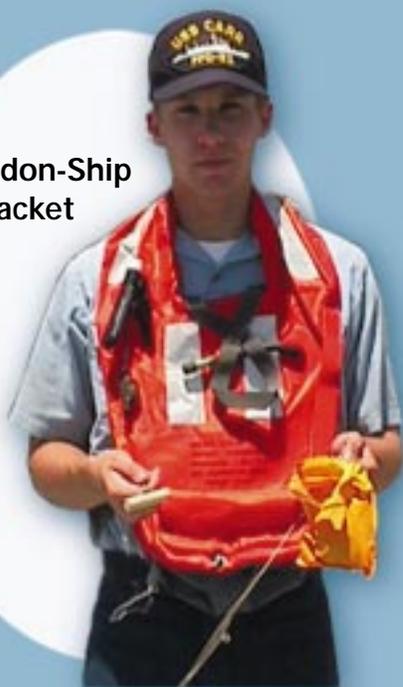
**Abandon-Ship
Life Jacket**

Inflatable Abandon-Ship Type With Pouch

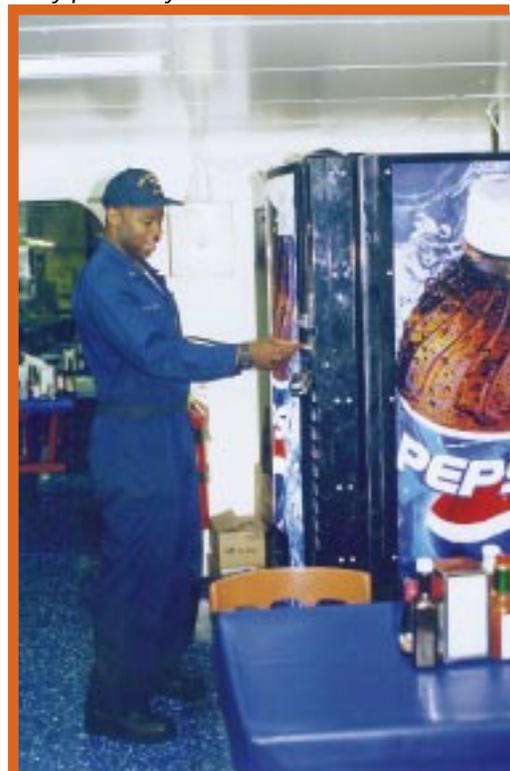
Electrician’s mates looking for overfused conditions aboard ship should pay particular attention to the circuits supplying power to such equipment as vending machines...

The most commonly overfused circuits are those supplying power to personal computers, TVs, VCRs, mess refrigerators, and entertainment-system components. Some equipment, such as high-speed buffers and refrigerators, draw a lot of current when you first turn them on. Accordingly, only those buffers that operate on a 15-amp fuse without overloading a circuit are approved for shipboard use. Authorized refrigerators are those purchased through the supply system and hard-wired to the ship’s electrical system.

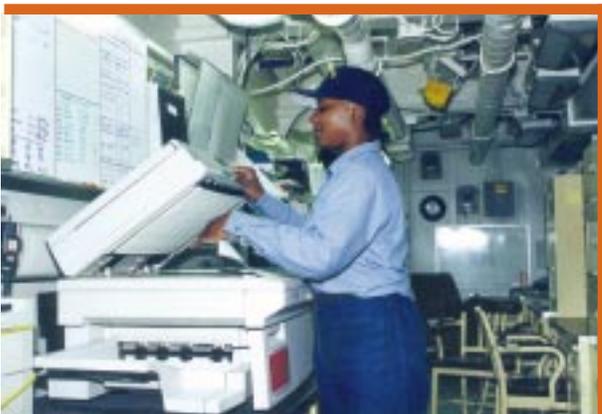
◀ ...and copiers, as well as entertainment equipment, buffers and personal computers.

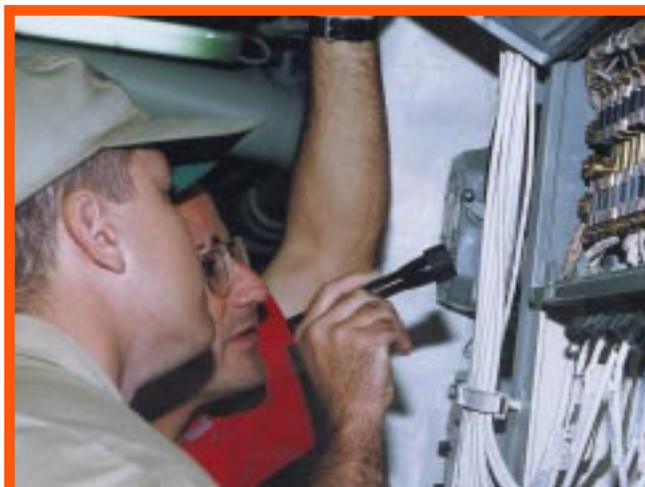
▲ **A Naval Safety Center surveyor checks a ship's fuse panel as a crewman observes. Overfusing, loose connections, grounded circuits, and frayed wiring are some of the common electrical problems found during surveys.**

This author admits that overfusing is a concern aboard many ships, but he feels the worst fuse-box problems are loose connections, grounded circuits, and frayed wiring.
